Australian Government
Department of Defence
Defence Science and
Technology Organisation

Helicopter Transmission Oil Discolouration

Air Vehicles Division
Defence Science and Technology Organisation

DSTO-TR-2672

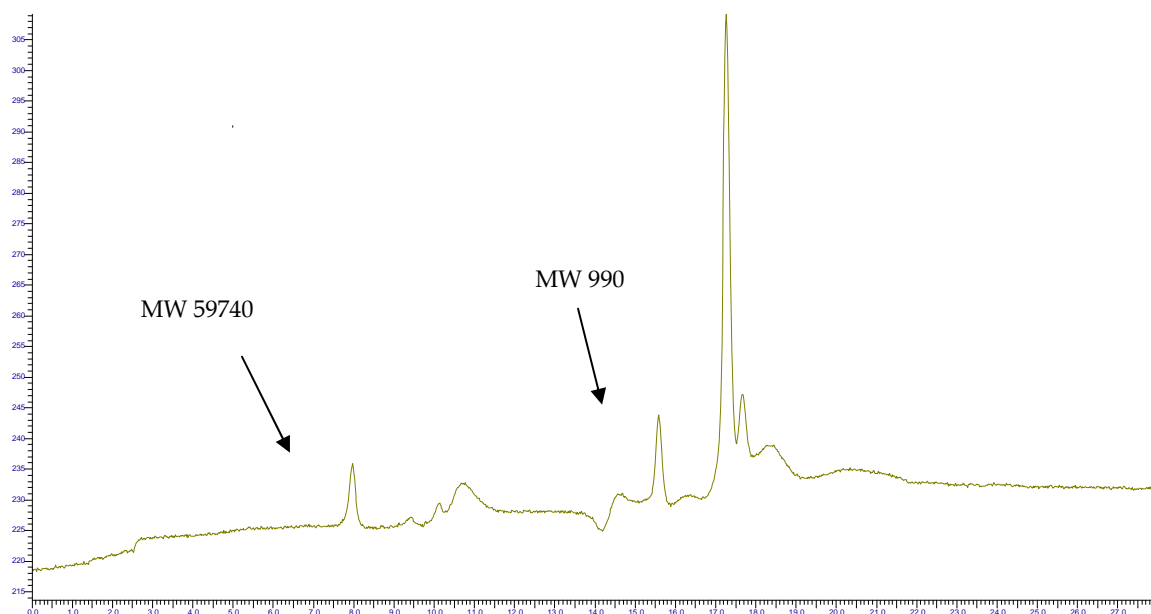
The molecular weights of the isolated purple precipitate and the metal quinizarate standards were examined to determine if the precipitate was due to the formation of insoluble polymers, (Table 3, Figure 5. It was observed that the purple precipitate did contain a range of high

molecular weight components that were similar in weight range to the three metal chelates indicating that metal quinizarate polymers had been formed.

Figure 5. GPC-Refractive Index chromatogram of Black Hawk purple precipitate.

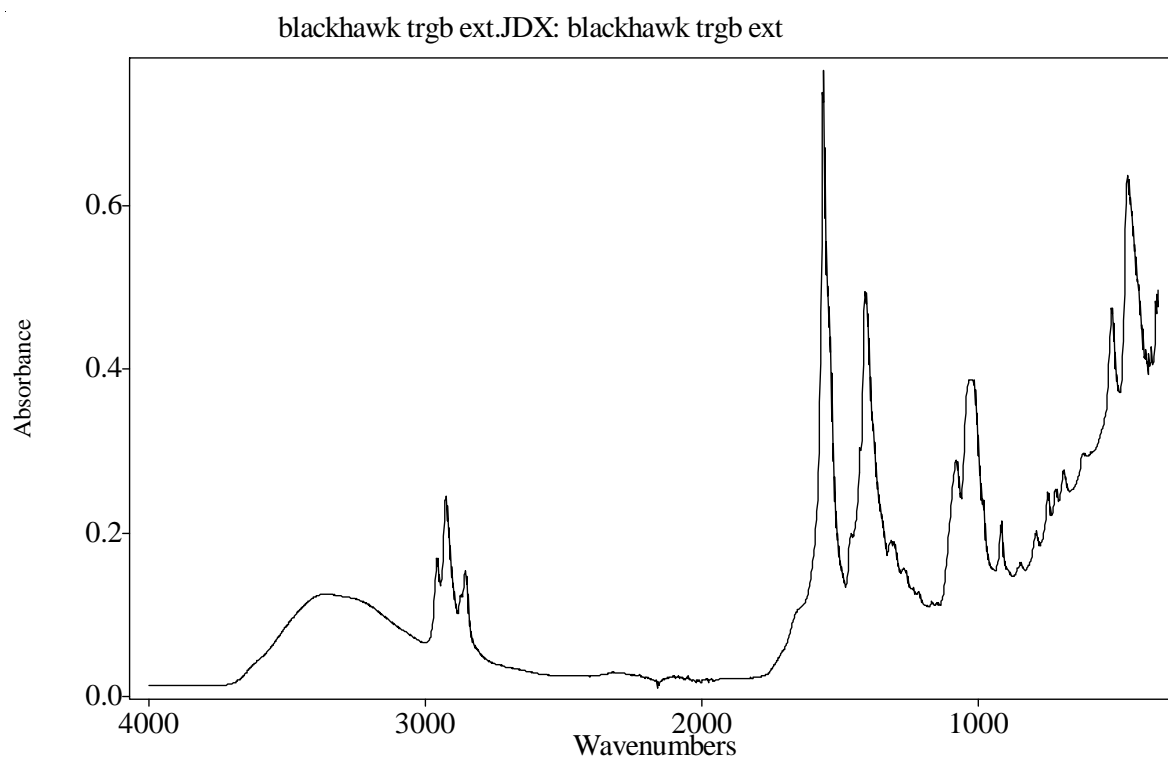
The Black Hawk precipitate was examined by FTIR and compared against the metal quinizarate standards. Dominant peaks were observed at 1560 cm^{-1} and 1410 cm^{-1} which were attributed to asymmetric and symmetric CO_2^- stretches of a carboxylate group [15]. A shoulder peak at 1530 cm^{-1} is due to a shift in the $\text{C}=\text{O}$ carbonyl peak of the quinizarin complexing with a metal salt, Figures 6, 7 and Table 4.

Figure 6. FTIR purple precipitate showing carboxylate group at 1560 and 1410 cm^{-1}

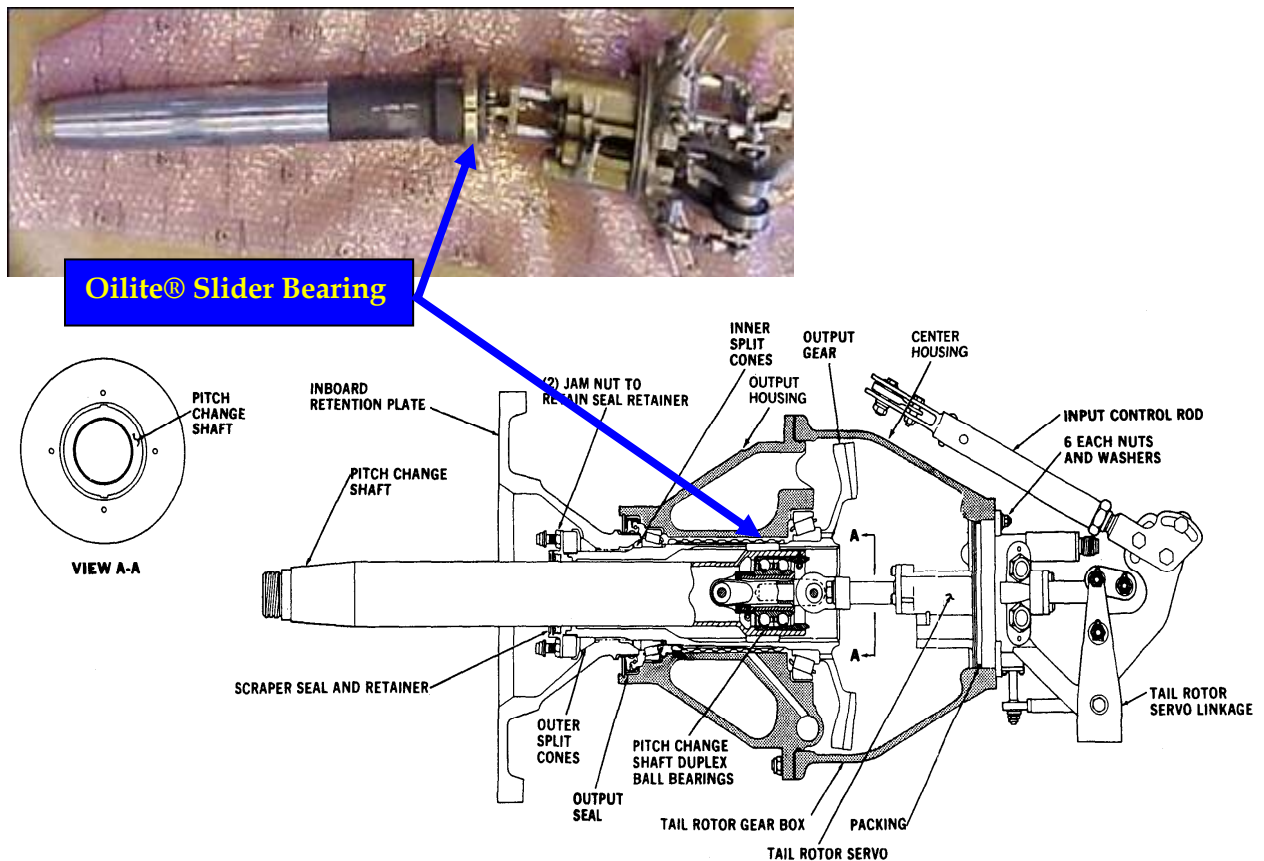
The pitch change shaft for the tail rotor blades passes through the oil-wetted section of the gearbox and is fitted with an Oilite® bronze slider bearing to accommodate sliding of the shaft (see Figure 1). It is expected that this bearing will wear in service and that the particles generated from that wear will also accumulate in the oil. At present, the degree of slider bearing wear is assessed by one of the following methods:

There is currently no indication that the Oilite® slider bearings are experiencing any abnormal wear. Wear particles accumulating in the oil due to normal in-service wear of the slider bearing would be expected to react directly with the quinizarate and form the purple discolouration/deposit since the bronze bearing material is copper-rich. The serviceability check for the TRGB specifically states that purple discolouration is not a reason for rejecting the gearbox [14].

Figure 7: Cross-section of Seahawk/Black Hawk TRGB showing location of Oilite® slider bearing

3. The TRGB Bronze bushing should be checked for excessive wear if the TRGB oil continues to discolour significantly after an oil change out.

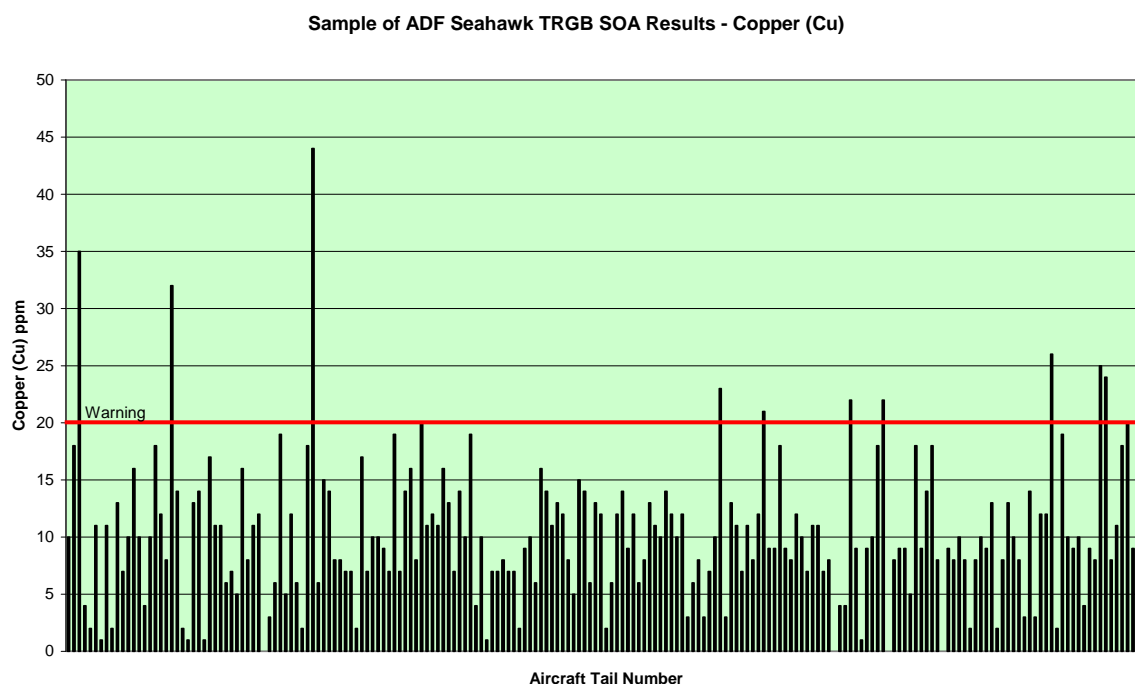
1. By measuring the level of copper in the Spectrometric Oil Analysis (SOA) reports. This oil analysis technique is currently only applied to ADF Seahawk aircraft. The technique is limited to detecting particles less than 8 micron (approximately), however it should detect slider bearing wear. The relative movement of the Oilite® bearing is exclusively sliding and therefore any debris generated is expected to be within the detectable range of SOA. Historical SOA results from Seahawk confirm that copper is being detected (see Figure 2).
2. By visual inspection and dimensional check as part of the routine flight controls inspection. This inspection specifically contains limits for nicks, dents, scratches and outer diameter wear [18].

Figure 8: Sample of ADF Seahawk TRGB SOA Results for Copper (Cu)

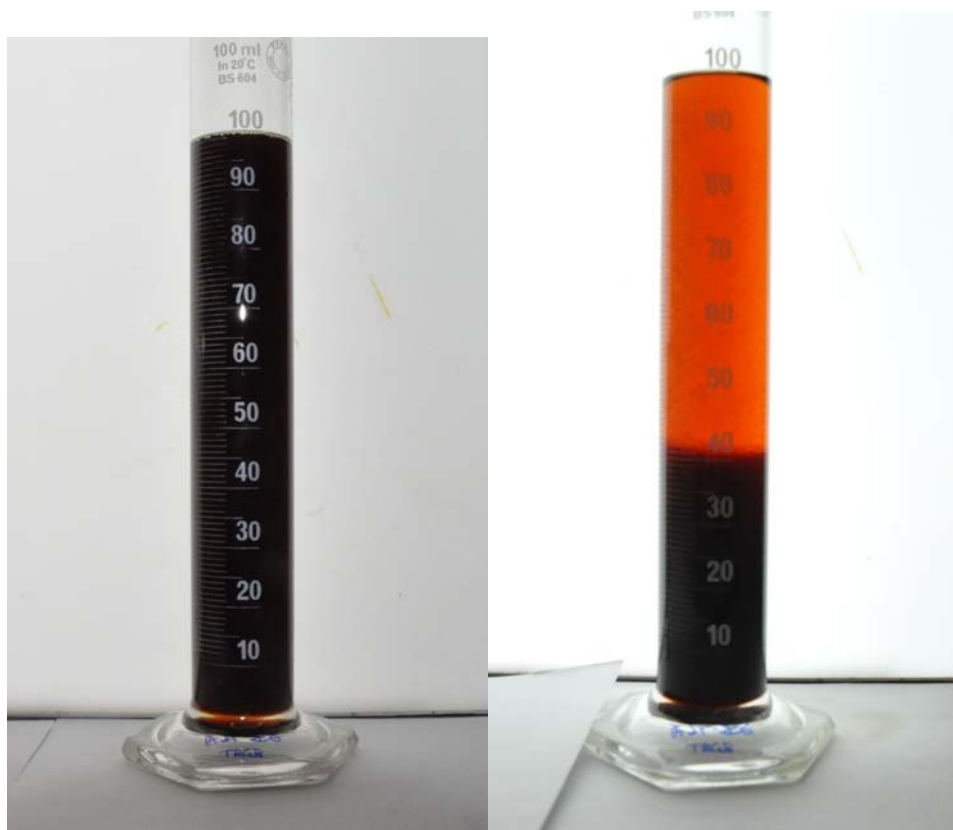
Figures A1 and A2. A25-206 TRGB oil before and after 48 hours standing

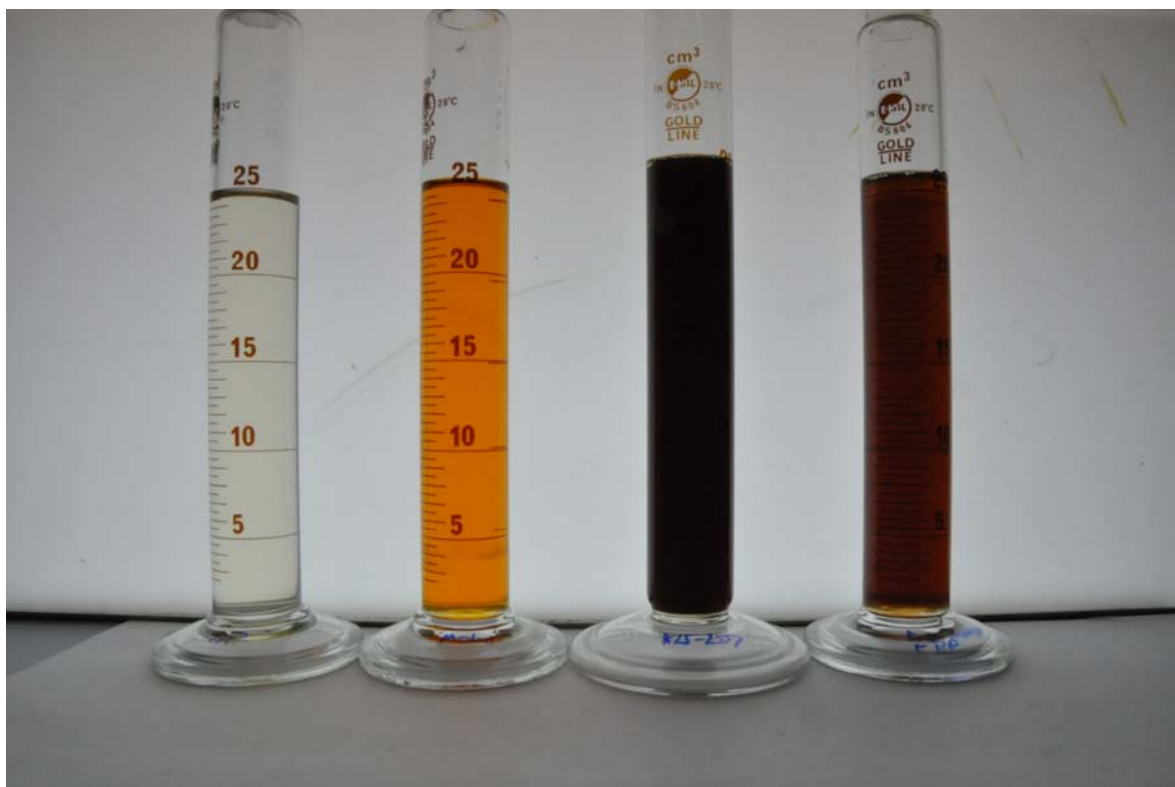
Figure A3. MIL-PRF-23699 Fluids

Left to right: Fresh BP Turbo oil 2380, fresh Mobil Jet Oil 2, Discoloured A25-207 TRGB oil. 50% A25-207 TRGB oil mixed with BP Turbo oil 2380.

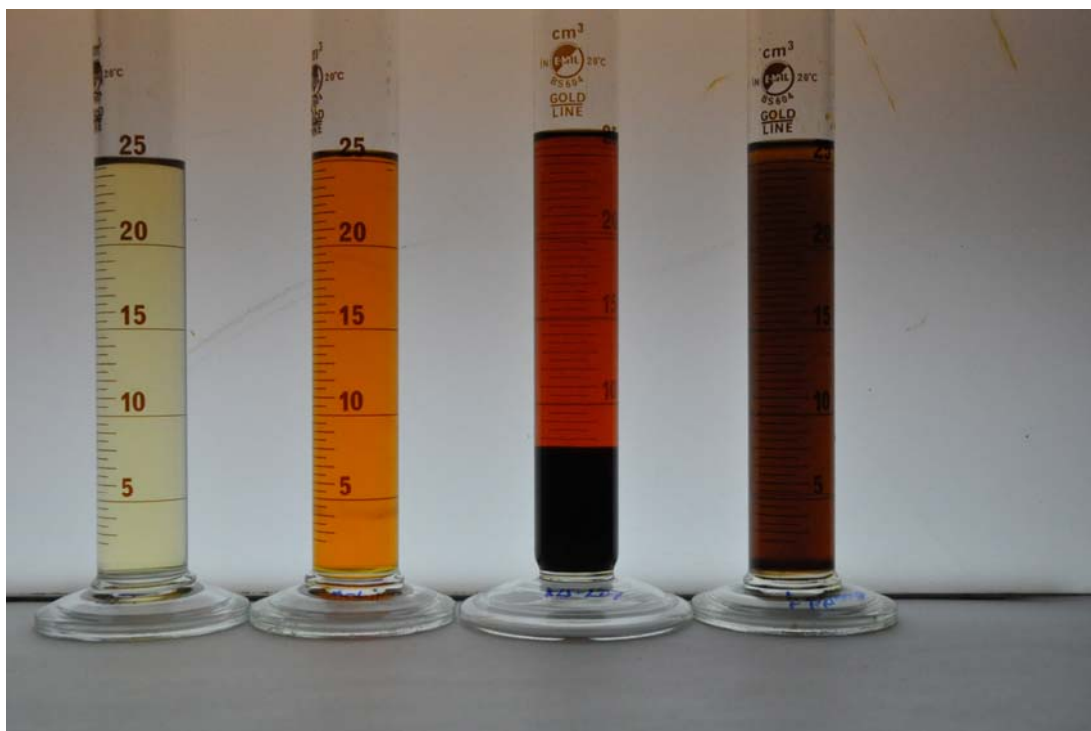
Figure A4. MIL-PRF-23699 Fluids after 48 hours standing.

Left to right: BP Turbo oil 2380, Mobil Jet Oil 2, Discoloured A25-207 TRGB oil. 50% A25-207 TRGB oil mixed with BP Turbo oil 2380. Note the BP Turbo oil 2380 was observed to darken in colour after 48 hours.

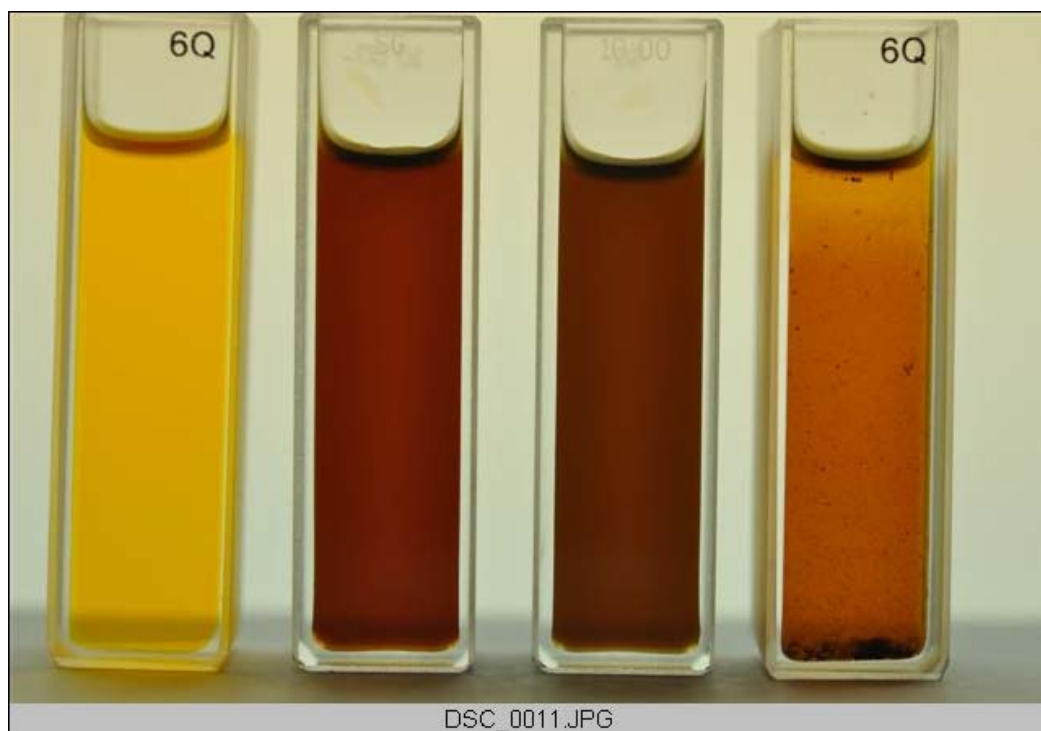
Figure A5. Oil samples from left to right: Fresh Mobil Jet Oil II; A25-107 TRGB; A25-204 TRGB; A25-107 TRGB with precipitate (samples from 2005 archive photo)

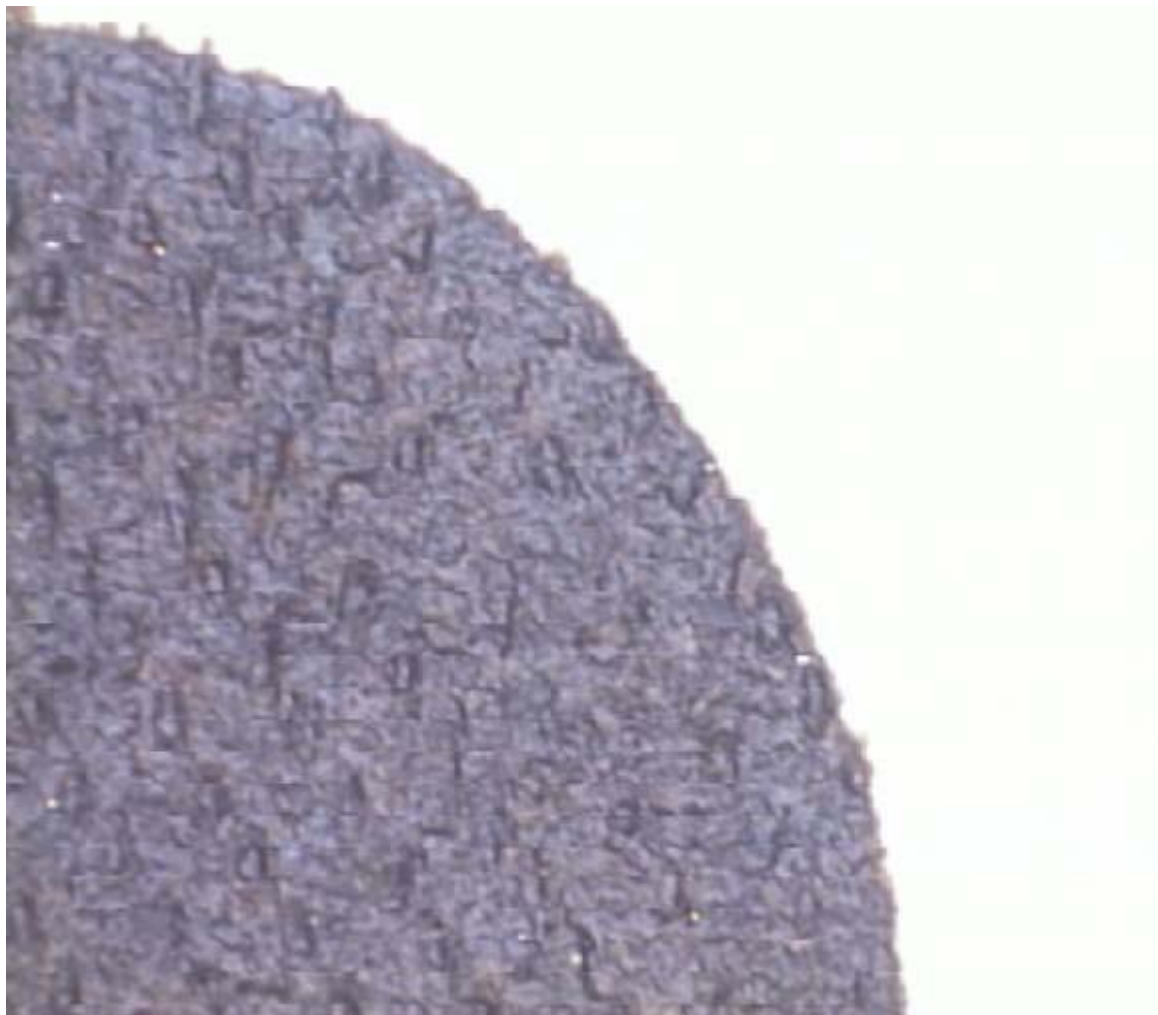
FigureA 6. Filtered and methanol washed "purple" precipitate

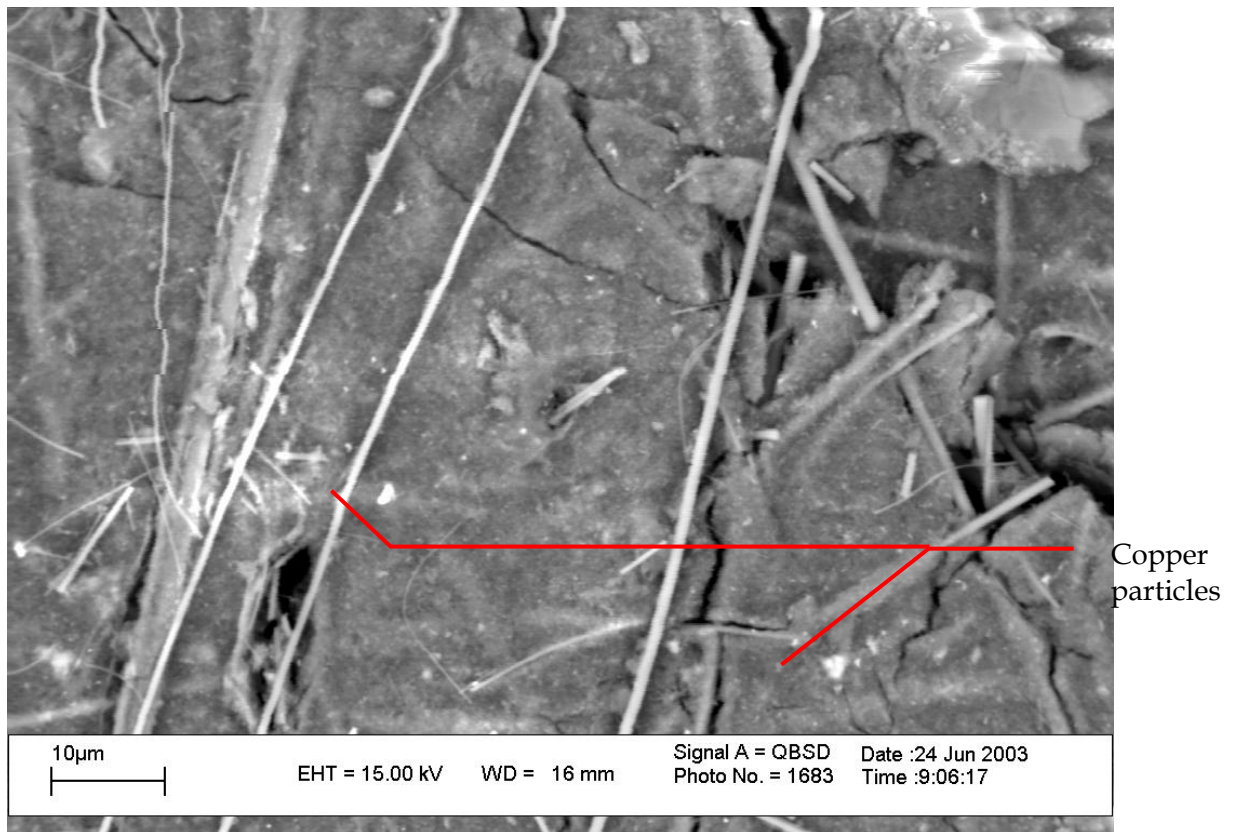
SEM analysis of the precipitate found a significant quantity of copper rich particles entrained in the bulk precipitate, (Appendix A). The metal particles may provide evidence for continued depletion of the quinizarin additive as they dissolve in the oil and may be the cause of the observation that once the oil has begun to show a colour change it will tend to darken with time.

Figure A7: Backscatter Electron Image of purple precipitate

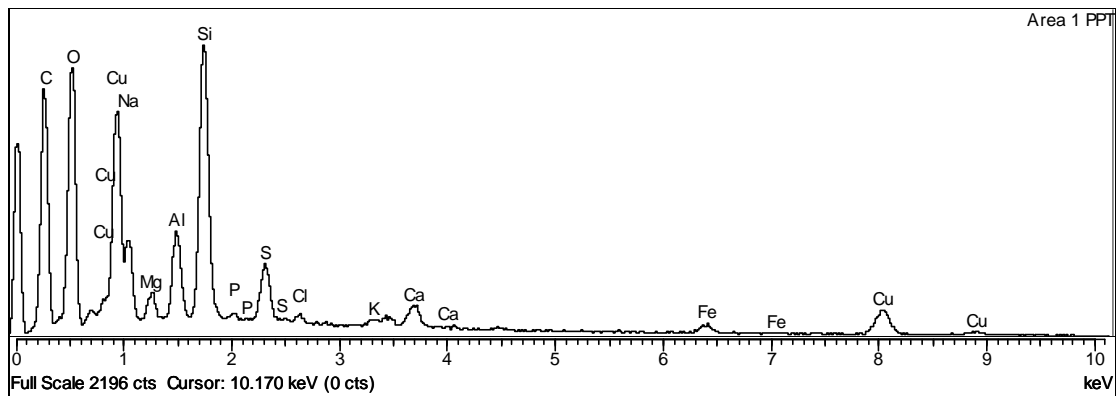
FigureA8: X-ray Scan of MTRG Oil Precipitate, from Figure A7.

(Note the peaks associated with Si, Na, Al, Ca, O and K are at least in part due to the filter media). The C, Cu, Mg, S and Fe is associated with the precipitate

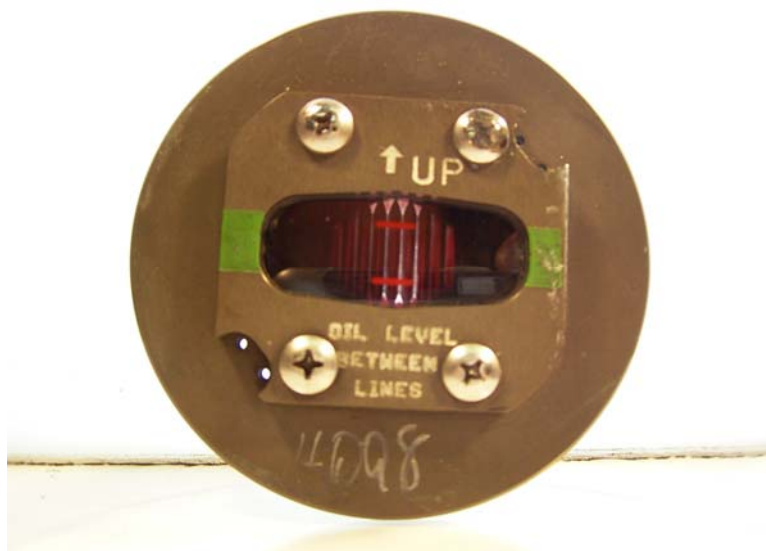
Figure B1. Sight glass from a Black Hawk, rear lit showing obscuration with red stain

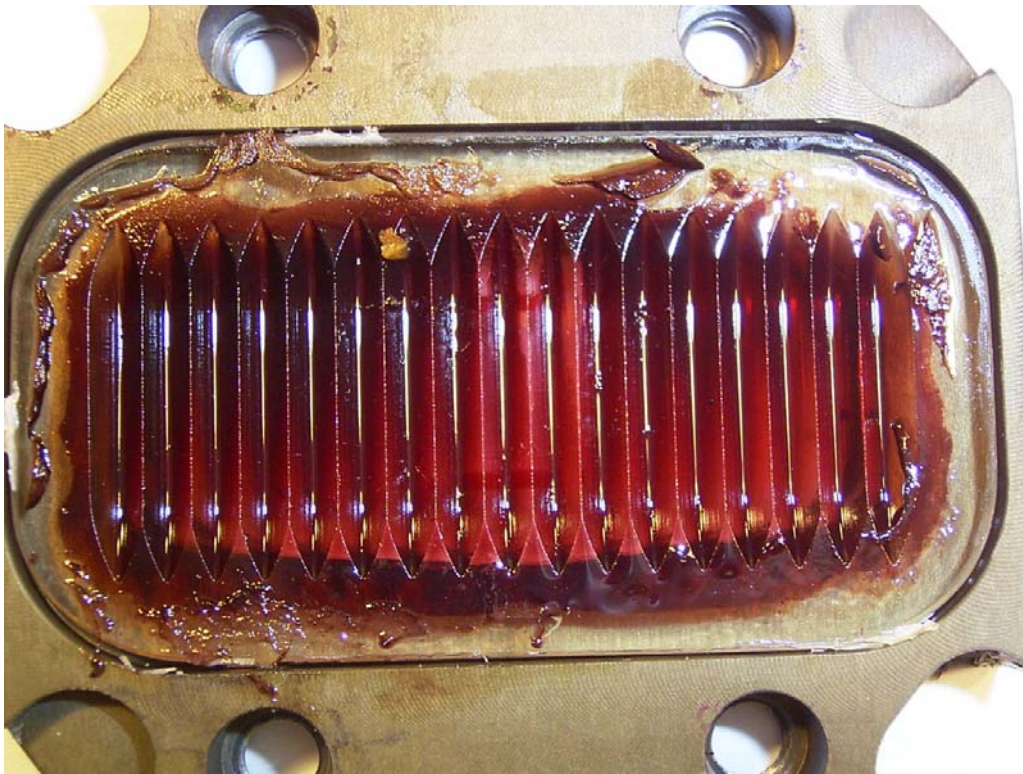
Figure B3. Sight glass inside face showing red stain and white grease like deposit
